Shoreline Movement Study, Point Peron Rockingham

Department of Transport
New Coastal Assets Directorate
Coastal Infrastructure Business Unit
Marine House, 1 Essex Street, Fremantle WA
PO Box 402 Fremantle, Western Australia 6959

Review	Issue Description	Author	Reviewed By	Date
A	Draft	SB		May 09
0	Final Draft	SB	KI, CB, LR, FL	16 June 09
1	Final	SB	DEC	16 Dec 09

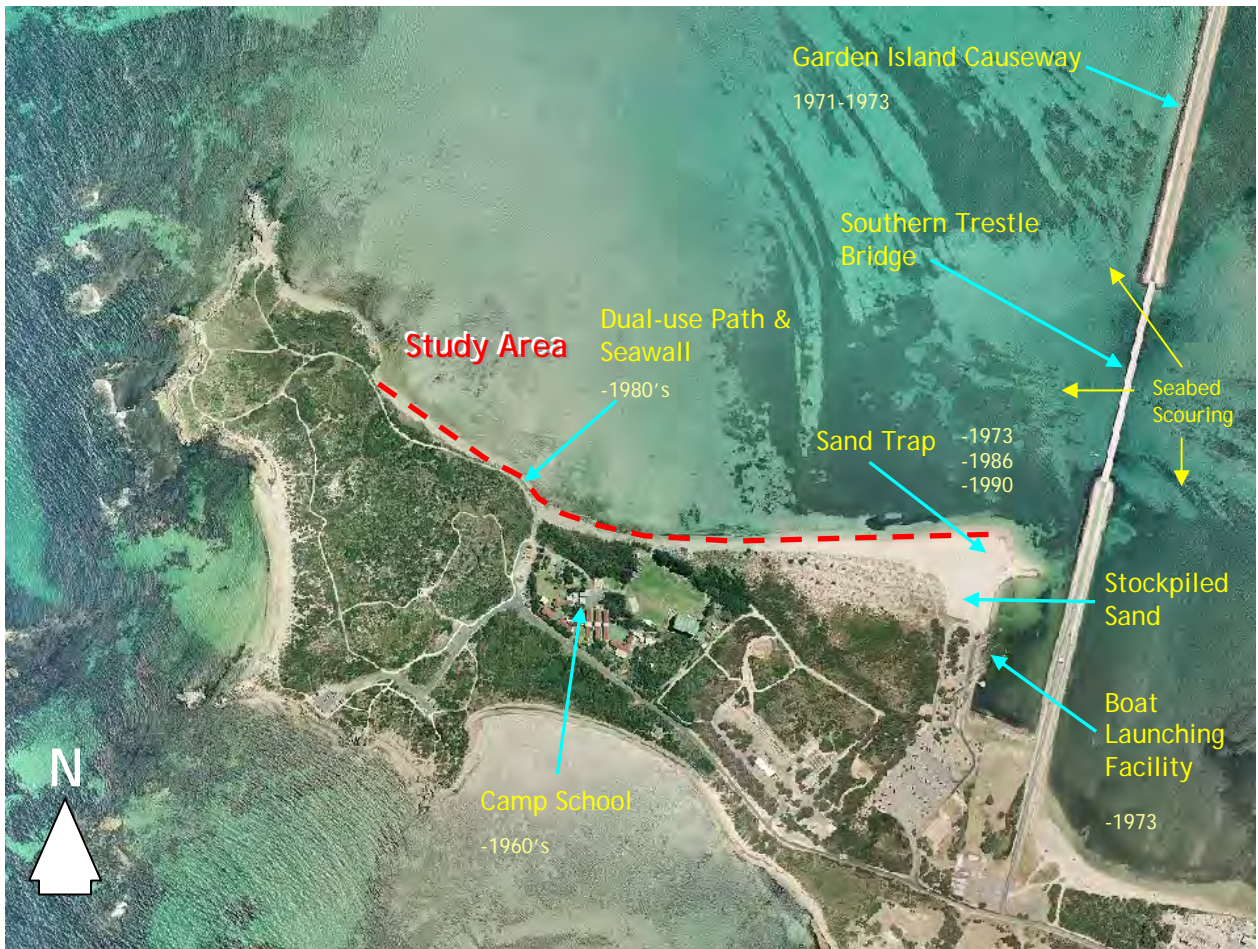
Figure 2: Features of Point Peron including construction dates (2009 image)

The influence of the Causeway has also been reported on by the Cockburn Sound Management Council (2003). Within this report, the Council states that the Causeway's presence has impacted upon the strength and direction of natural currents that pass through the Causeway's two trestle bridges. This has caused local currents to strengthen which has increased sediment movement and scouring of the seabed. Distinct scouring of the seabed around the northern and southern trestle bridges can be seen on recent aerial photographs (Figure 2).

A seawall was constructed in the late 1980's along the coast adjacent to the dual-use path (Figure 2). Its purpose was to provide protection to the path from wave action. It is likely that the seawall was not formally designed and limestone rocks were simply deposited along the path's edge. The seawall is

currently in poor condition with large gaps and there are cracks and breakages along the path's edge (Figure 3).

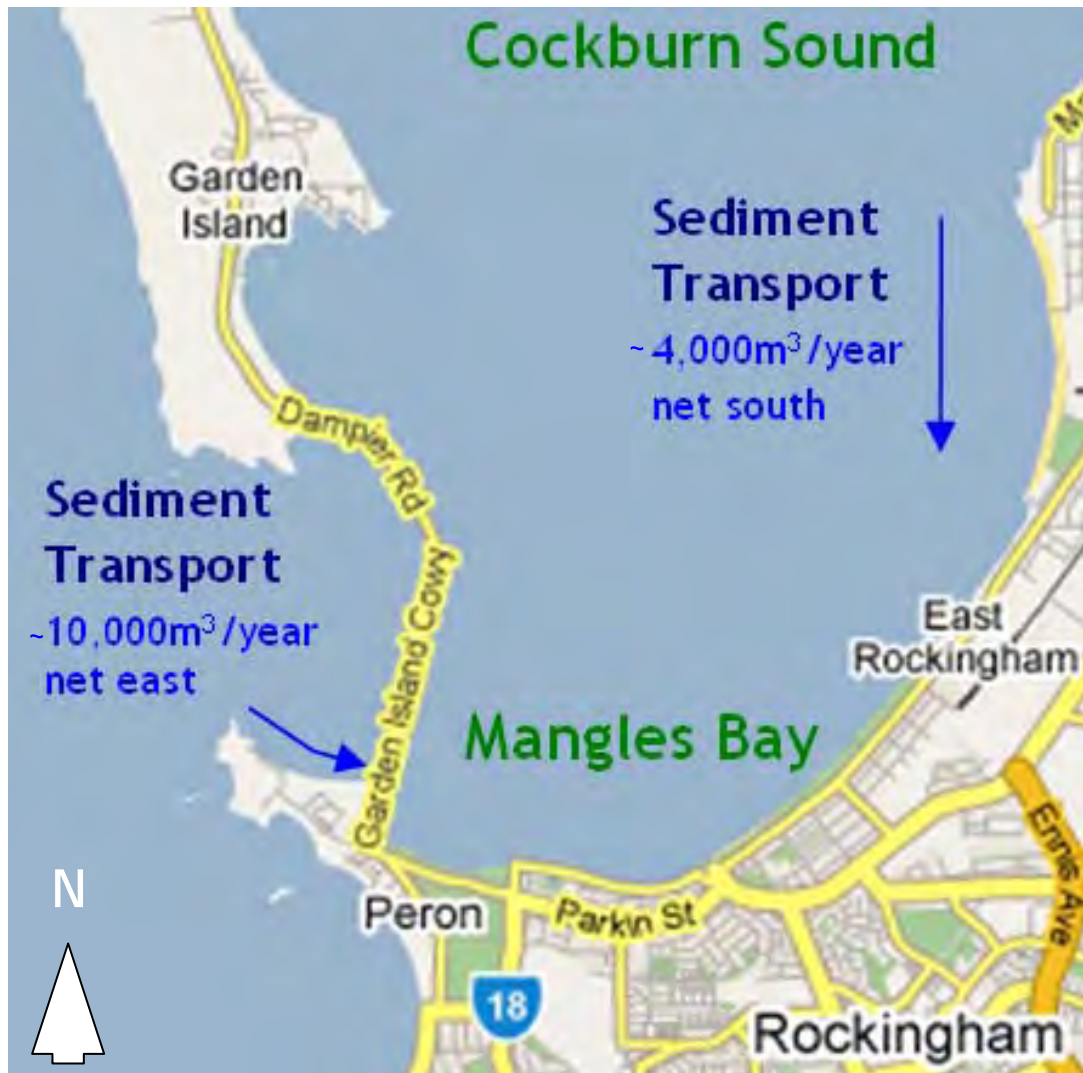
Figure 13: Sediment transport in the study area and Cockburn Sound. NB: Rates are approximate (source: Google maps)

Sediment is transported east along the coast in the study area. This is likely due to swell waves from the south west which arrive throughout the year and wrap around the cape (Figures 8 & 10). South-south westerly summer sea waves and winter storm waves are also likely to wrap around the cape. The Causeway blocks any waves from the east and therefore inhibits sediment moving to the west.

Based on estimated excavation volumes at the sand trap (Table 2), the annual net sediment transport is in the order of 10,000m³ to the east (Figure 13).

Sediment is transported southwards along the eastern edge of Cockburn Sound into Mangles Bay (Figure 13). South-westerly swell waves may wrap around the north of Garden Island and travel south into Mangles Bay. Winter sea (wind) waves from the north west also travel around the north of Garden Island and move into Mangles Bay. During summer there is unlikely to be sufficient fetch to generate sea waves from south-south westerly winds which are capable of moving significant amounts of sediment northwards. The annual net sediment transport is approximately 4,000m³ to the south (DPI, 2004).

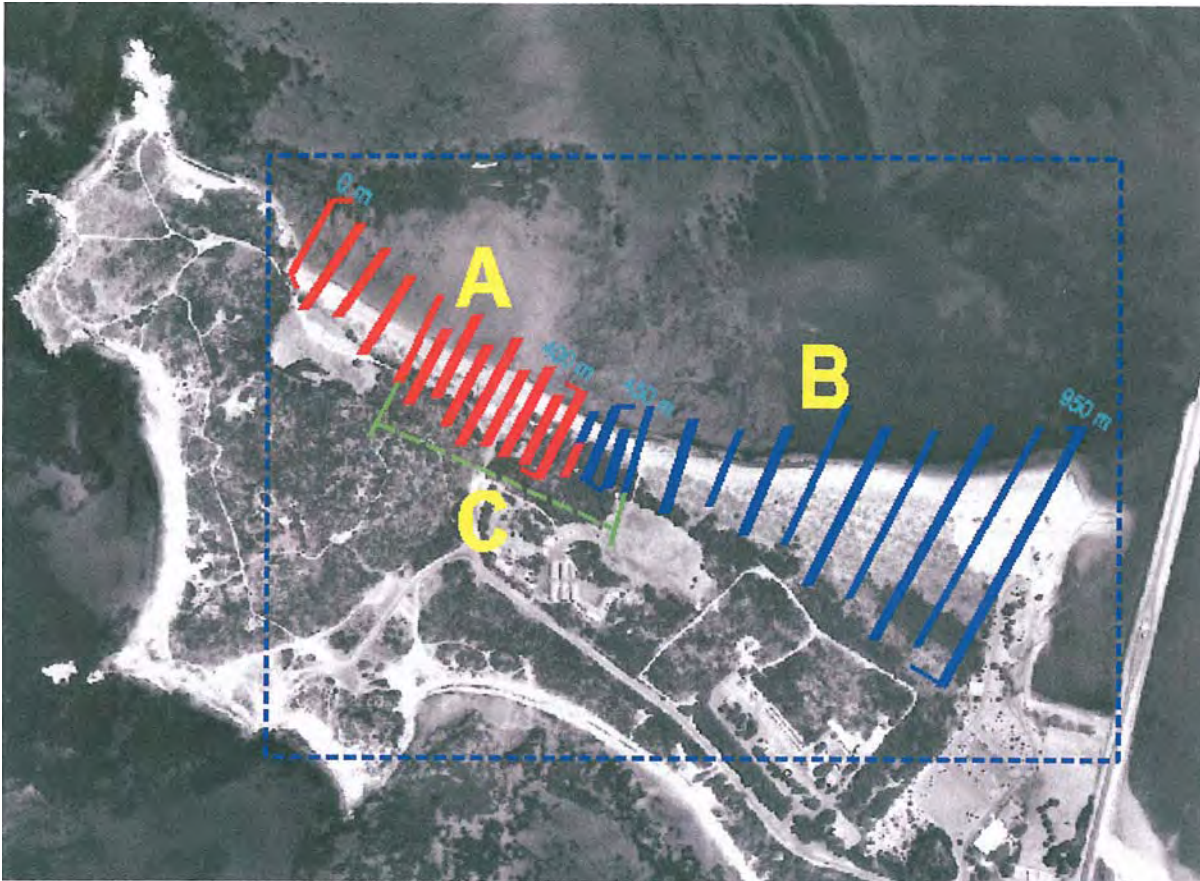
Figure 16: The study area at Point Peron (A: Western side; B: Eastern side; C: Dual-use path to oval) - 1998 photograph

The study area was divided into two sections, a western (chainage 0 - 400m) and an eastern side (chainage 450 - 950m) due to the different changes that have occurred in each over the 66 year period. Figure 20 displays a graph of the average changes for both sides. Average changes for each year were calculated by averaging the distance between the 1942 vegetation line and the year of interest for each of the 50 m cross-section lines. The Garden Island Causeway (1971-1973) appears to have had an impact on both the western (0-400 m) and eastern (450-950 m) sections of the shoreline. Prior to the Causeway, 4 years recorded between 1963 and 1971 showed signs of a dynamically stable shoreline on both sides (eastern and western). Both sides began to accrete after the causeway was built. The 4 year period between 1971 and 1975 saw an accumulation of approximately 31 and 14 metres for the western and eastern locations respectively. From 1975 onwards, the western side has been generally eroding whilst the eastern side has been steadily accumulating, with 45 m accretion from 1993 to 1998. Between 1998 and 2008, the beach in the western section (0 - 400 m) has retreated approximately 25 metres.

The shoreline along the study section is likely to still be adjusting to the presence of the Garden Island Causeway. Before the Causeway, there was wave action from the west and the east. Since the Causeway's construction, waves from the east have been limited. Waves from the west are now the sole driver of longshore sediment transport. The original sand trap groyne that was constructed during the same period as the Causeway, provided shelter for the boat launching facility from sedimentation. Sand accumulated on its western side until the groyne was "saturated". Between 1986 and 1990, 2 extensions were constructed. The structure was again saturated with sediment, hence annual excavation works at the sand trap.

However, the western side is still adjusting and this involves realigning with the shoreline on the eastern side. This process of realignment is likely to be a significant driver of the erosion in the western half of the study area.

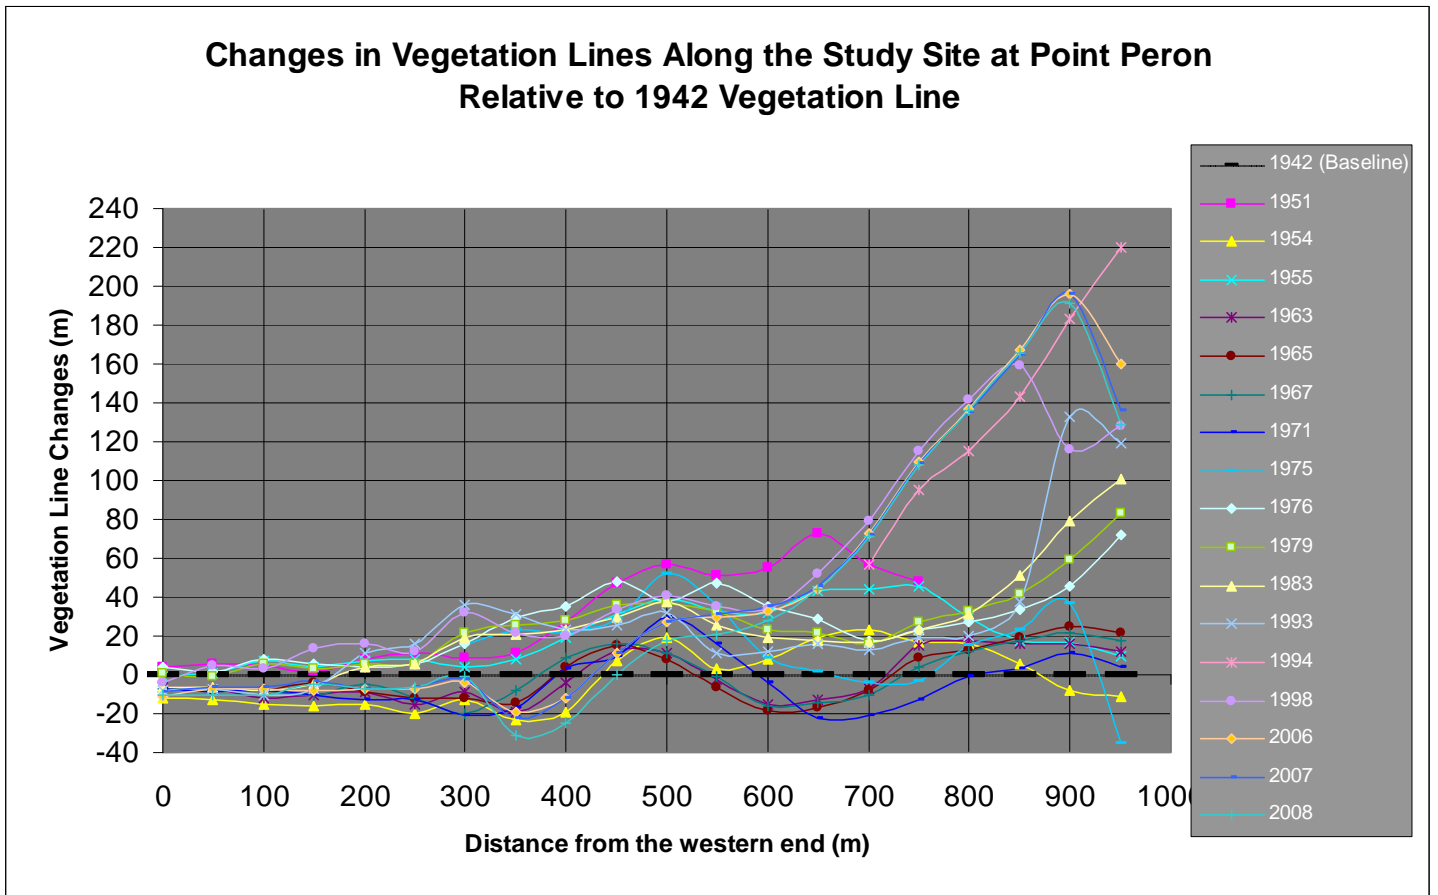
Figure 17: Changes in vegetation lines along the study area (from west to east) over a 66 year period for profiles 50 m apart

Vegetation lines for the 17 recorded years were plotted against the 1942 vegetation line. From this information, years of accretion and erosion can be tracked. Between 1971 and 1975, there was found to be an accretion of 31 metres on the western side and 14 metres on the eastern side of the study area. The recorded years from 1975 onwards show that the eastern section has been steadily accreting, especially between 1993 and 1998 (45 m). The western side has generally been eroding since 1975 onwards with the most erosion occurring between 1998 and 2008 (25 m).

Over the last decade the study area has experienced on average, 2.5 metres of erosion per year. The oval is currently approximately 25 metres away from the vegetation line and is less than five metres above AHD (Figure 12). If the recent erosion rate continues, then the oval could be subject to erosion in 10 years. During energetic storm events elevated water levels may cause the oval to inundate sooner. The mean storm water level is estimated to be approximately 0.9 mAHD. Under these conditions, significant erosion of the dune buffer is expected. The runup height of individual waves during a storm event (2.9 mAHD) is likely to cause inundation of the seaward edge of the oval and further accelerate erosion.

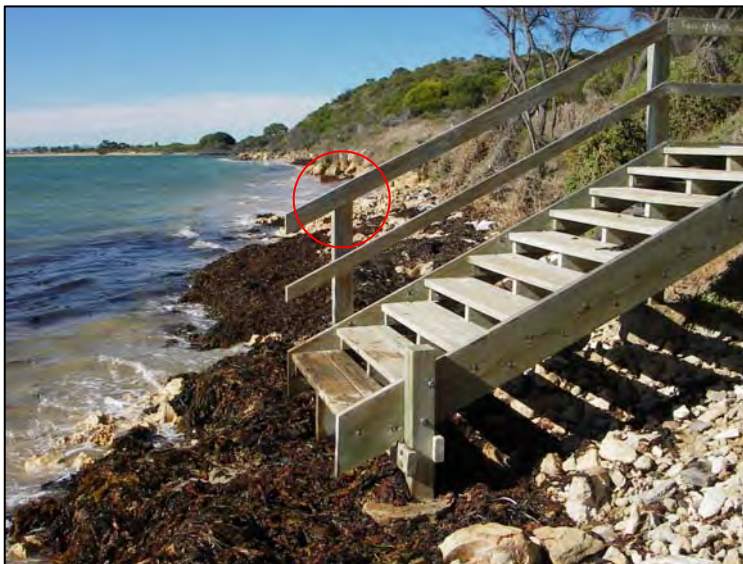
These photographs are captured from the western end of the study area near the stair access to the beach. Photograph 1 compares the beach height and water level with the end of the stairs (facing towards the seawall). Photograph 2 is taken from the bottom post of the stairs (facing towards the seawall).

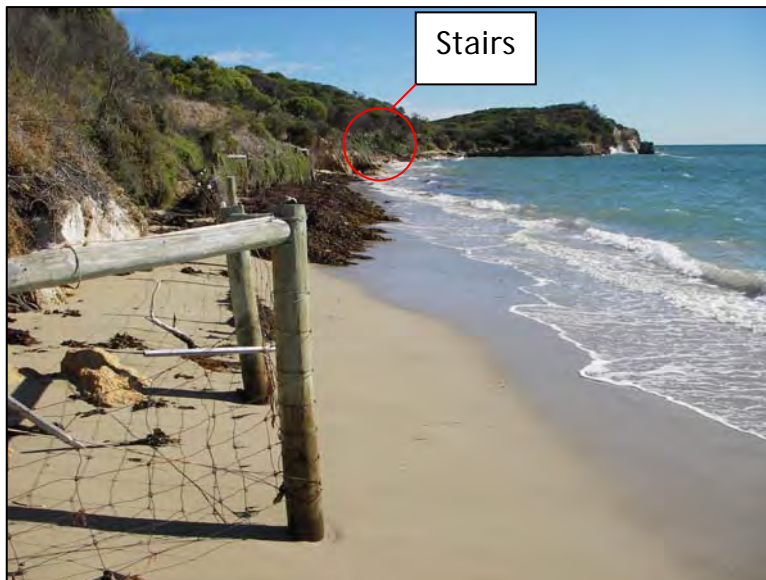
The following photographs are captured from the corner of a fence that runs along the edge of the vegetation line. The corner of the fence is about 25 m from two concrete tubes that are on either side of the path. Photograph 3 is taken facing back towards the stairs. Photograph 4 is taken facing towards the seawall.

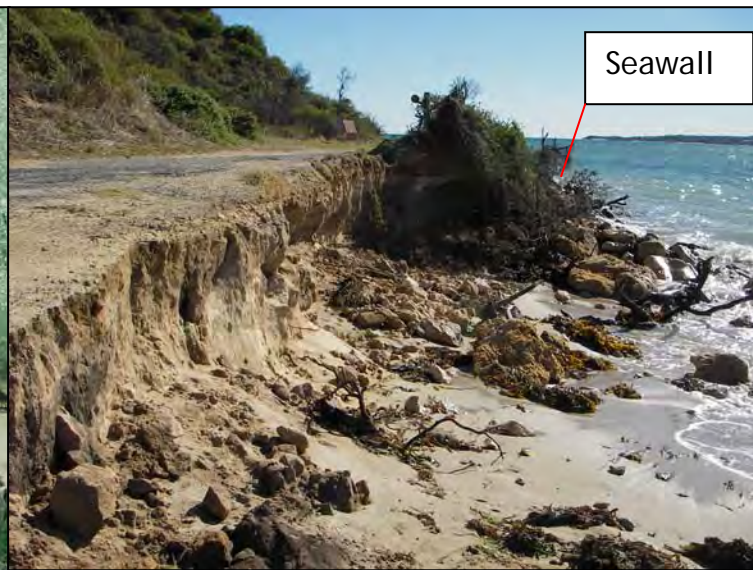
The following photographs are taken from a small eroded section alongside the path and in between the start of the seawall and the dune. Photograph 7 is taken in line with the 'Mangles Bay/Shoalwater Bay' sign, and facing towards the seawall. Photograph 8 is taken from near the start of the seawall towards the corner of the dune. Photograph 9 is taken from the corner of the dune and faces eastwards.

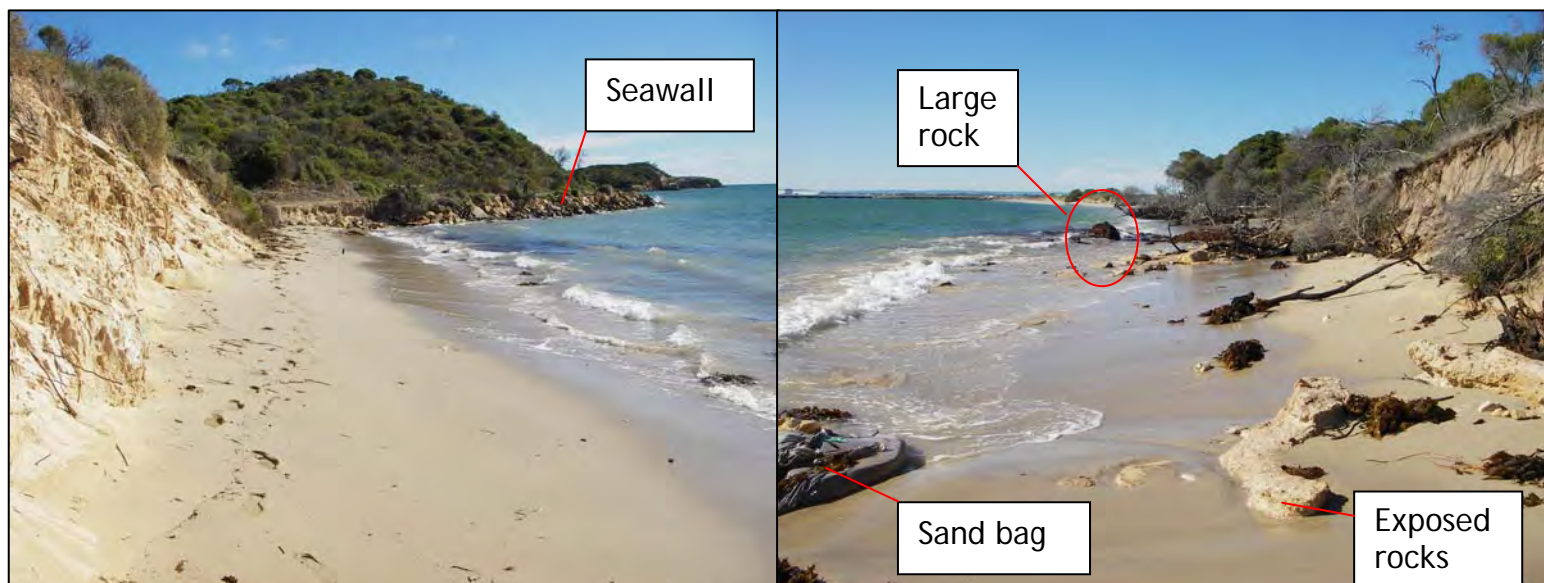
These photographs are taken from where there are exposed rocks along the beach. Photograph 10 is taken from the rocks and faces back towards the seawall. Photograph 11 faces east and taken just before the rocks and a large sand bag.

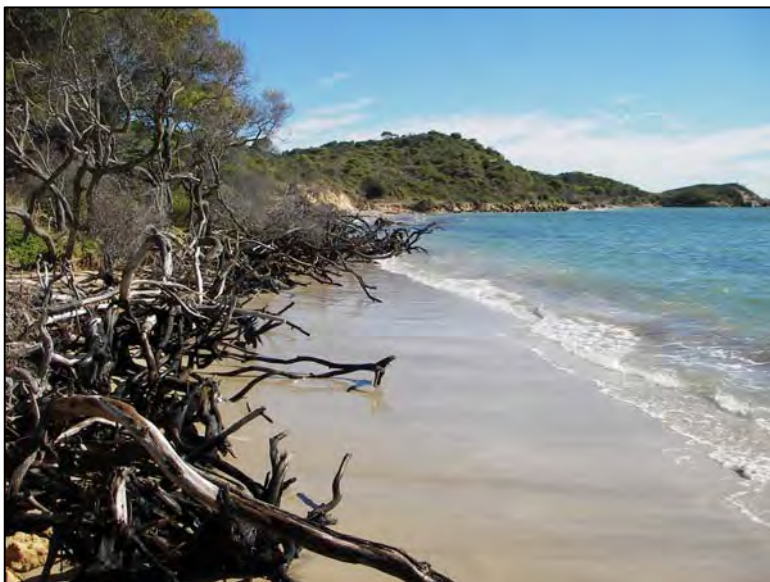
The following photographs are taken from the fence posts at the end of the oval's path to the beach. Photograph 12 is taken standing beside the right post (when facing the oval) and captures the beach towards the exposed rocks. Photograph 13 is taken standing beside the left post and faces eastwards along the beach.

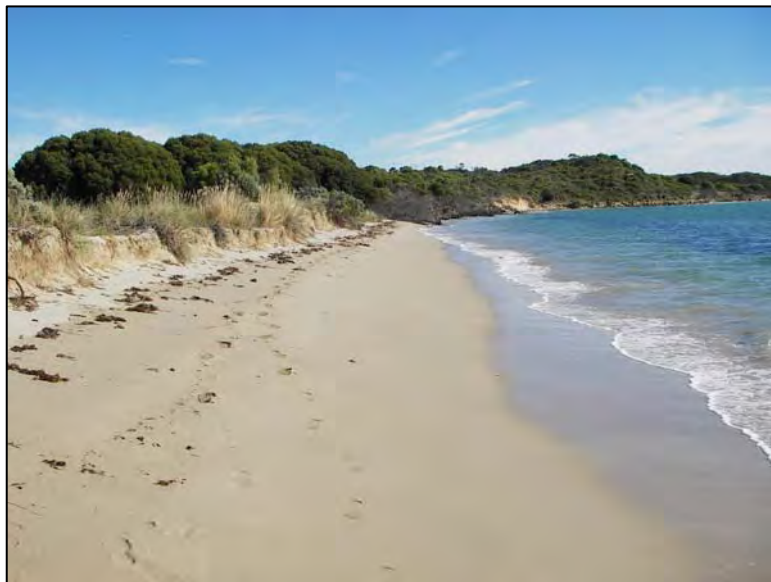
These photographs are taken in front of a large bush that protrudes from the vegetation line. It is approximately 140 m from the end of the oval's path. Photograph 14 shows the beach towards the oval and photograph 15 shows the beach towards the sand trap.

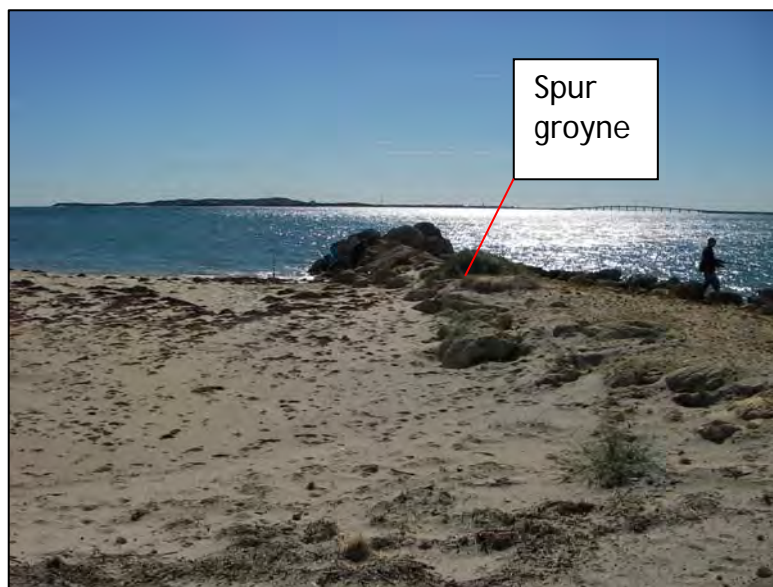
Photograph 16 is taken from the fence post at the start of the spur groyne and faces towards the spur. Photograph 17 is taken near the middle of the spur groyne and faces to the west.
